Veneer Finishing Hints

SHUSTER'S BUILDING COMPONENTS

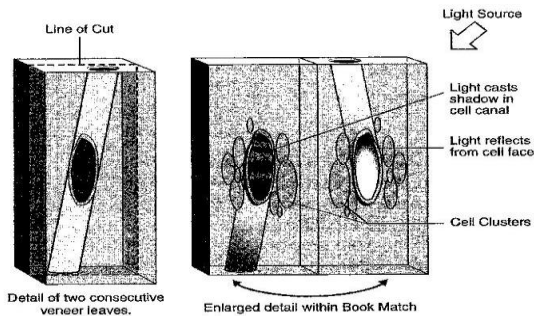
Blotches are dark and/or light areas that show up when stain is applied to the surface. They occur because certain areas of the veneer may be more or less porous. These absorb stain and reflect light differently. Barber pole effect occurs most commonly on book matched veneers. Book matched veneers consist of every other piece of veneer being turned over like pages of a book. The visual effect is one of symmetry at the splices. As the veneers are turned, a *tight* and *loose* face is alternated in adjacent pieces of veneers. They may accept stain and reflect light differently causing a noticeable color variation called “Barber Pole.”

Blotches and barber pole may be impossible to eliminate but can be visibly reduced. Reduction of visible blotching can be aided by proper sanding, sealing before introducing stains, and by choosing non-penetrating pigments – dyes, alcohol stains, or glaze – in lieu of penetrating stains such as oil and water. The barber pole effect can be reduced by sanding, bleaching, flitch selection and (when permitted or appropriate) by switching to a slip match layout. A heavy glaze may also help hide the barber pole effect, but it must be understood that this is a natural feature of certain wood species when combined with a book match layout.
